CONSTRUCTION PROGRESS DOCUMENTATION

# 528 TOWN CENTER

Aerial progress log for the Tannos Development Group mixed-use center at FM 528 and Clear Creek — marketed by the developer as Friendswood City Center. Percentages are visual assessments read from the survey imagery against the developer's site plan; they are documentation, not certified quantities.

TC528-003

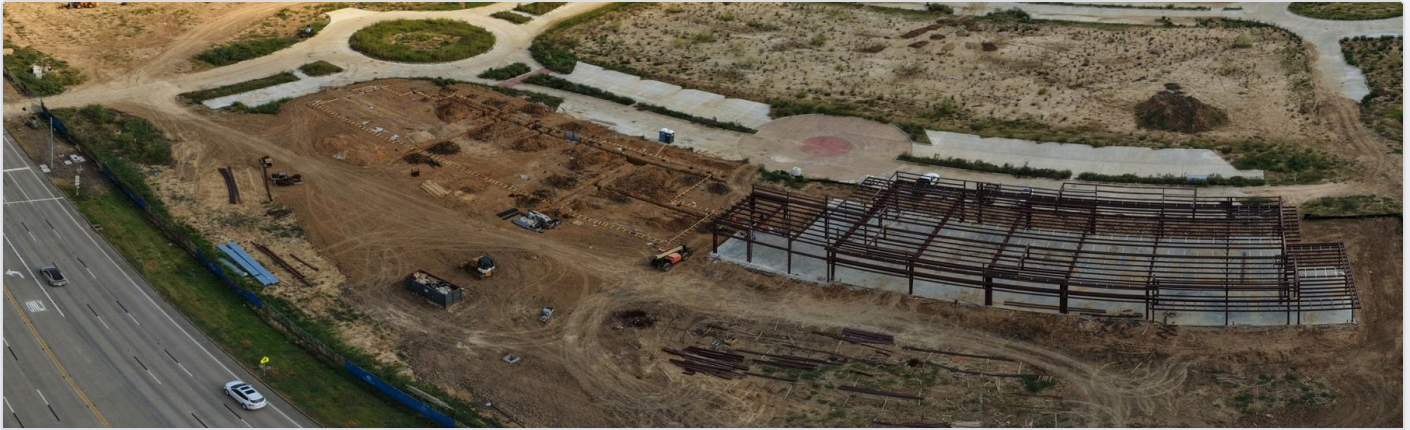
FIG. 01

Frontage looking south on 2026-10-06, 250 ft AGL — Retail 4 steel frame (right) and the Retail 5 footing layout (left). TDB Solutions.

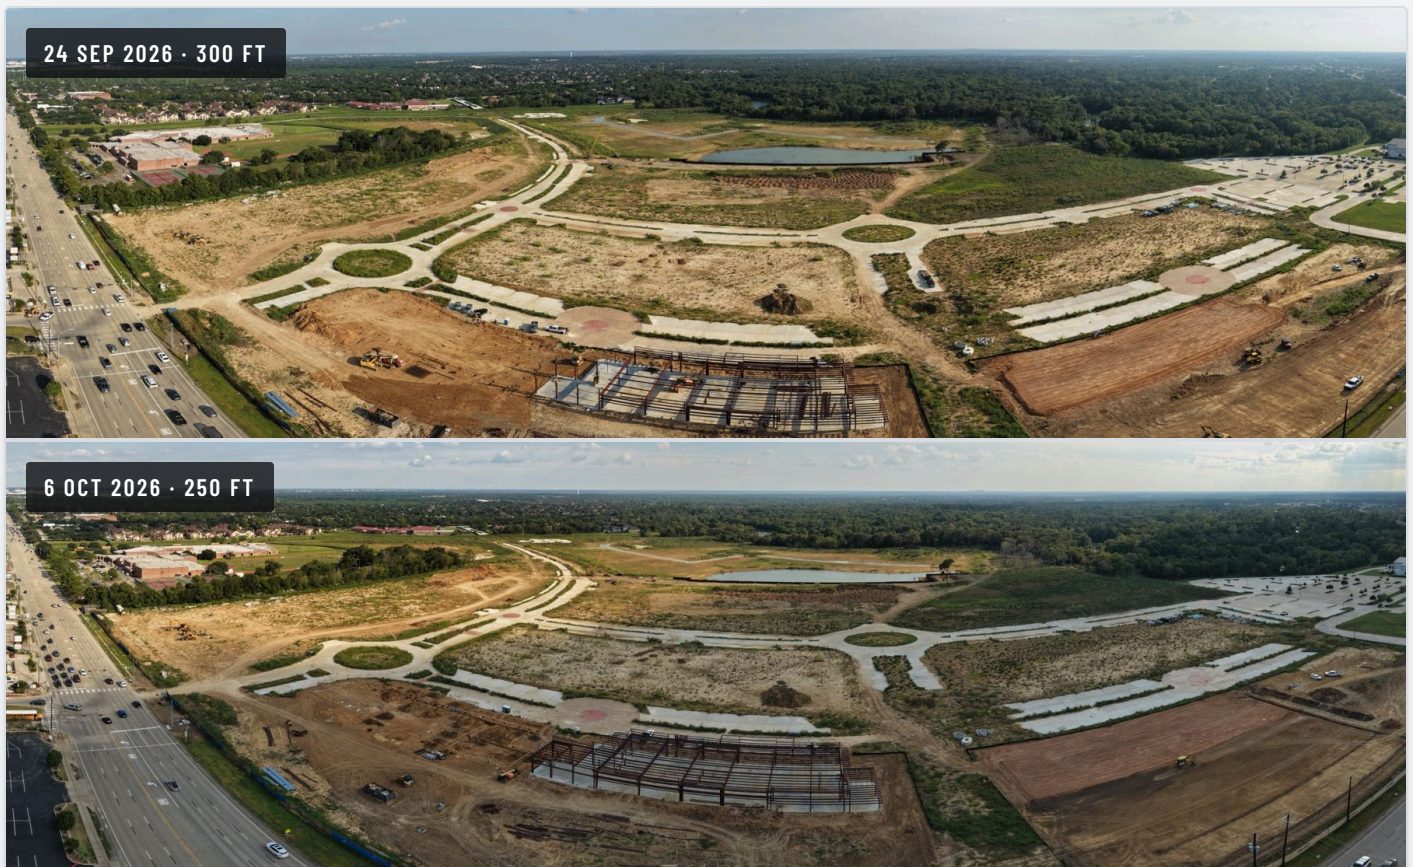
- **Retail 4 steel is framed across the full footprint.** On 11 September roof framing covered roughly the west third; today columns, beams and joists run the whole length of the slab. No roof deck, wall framing or envelope yet, and a telehandler is parked on the slab.

**FIG. 02** Same station, same direction. Altitudes differ (300 ft then, 250 ft now), so scale is slightly larger in the lower frame.

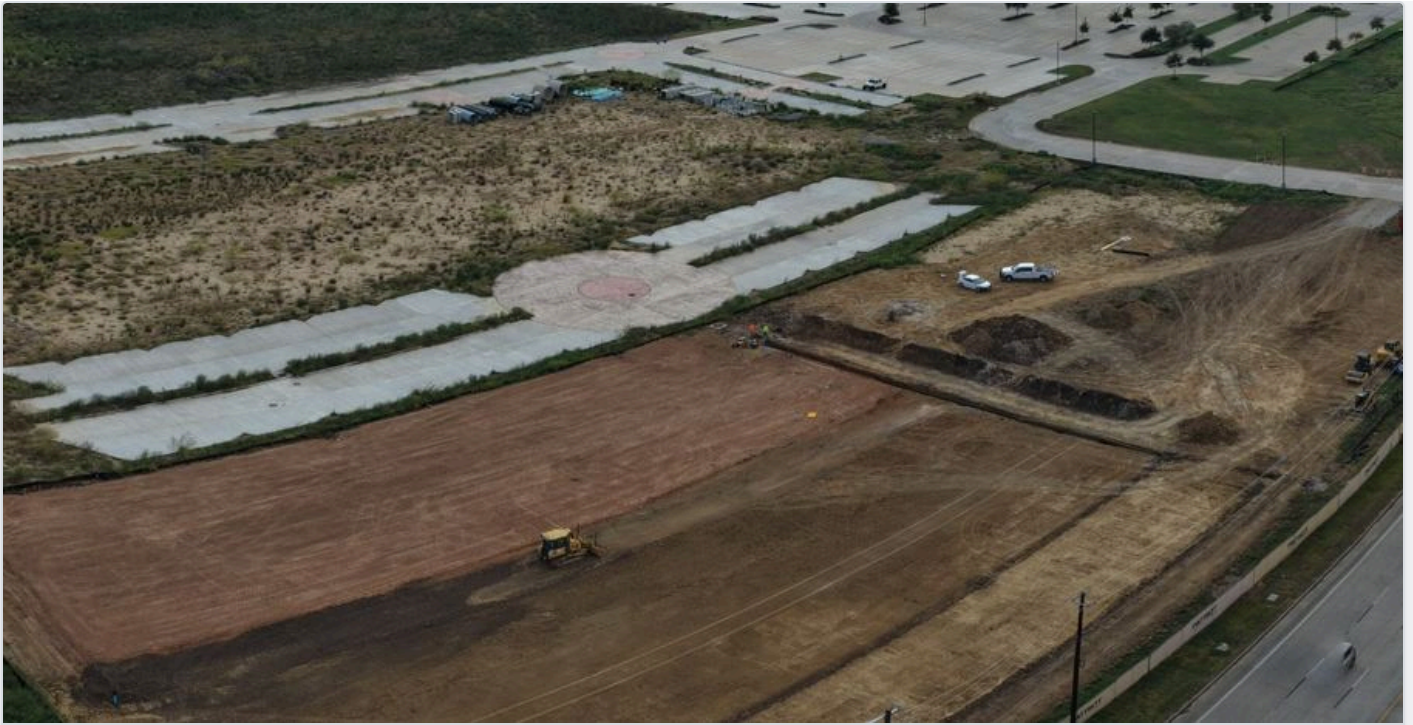
- **Retail 3 is fine-graded.** The pad that was rough red clay on 24 September has been dressed to a uniform surface with a dozer still working it and silt fence run along the edge.

- **New trench runs and site trailers** at the west end of the frontage beside Retail 2, with spoil piles, a roller and a dumpster. Storm pipe and precast structures are stocked on the drives for the next utility run.

**FIG. 03** Retail 3 fine-graded pad (left) and trench runs with site trailers at the west end, 2026-10-06.

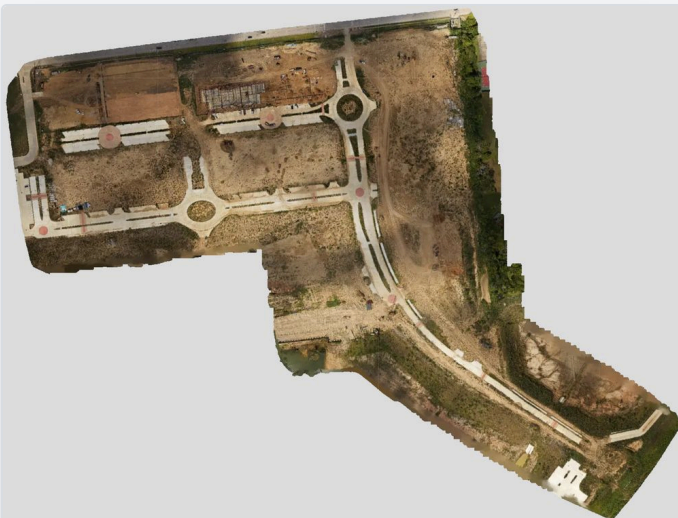
The mapping grid flown on 6 October has been stitched into a true-to-scale orthomosaic and a surface elevation model of the whole site. Every pixel is georeferenced, so pads, slabs and drives can be measured and overlaid on the developer's plan, and compared flight to flight.

**FIG. 04** Orthomosaic of the full site, 2026-10-06. FM 528 runs along the top edge.

- **Plan overlay on the orthomosaic.** The orthomosaic and elevation model are now in hand. Next is laying the developer's site plan over them so every pad is matched to the plan instead of read by position.
- **Steel erection sequence.** Same orbit on Retail 4 — next milestones are decking and wall framing.
- **Piling rig and sheet-pile wall.** Low pass on the crane and the full wall run so advance can be measured.
- **Retail 5 and Retail 3.** Slab-on-grade forming and pour are the next visible steps.
- **Property line annotation.** Mark it on the ortho so neighboring buildings never read as delivered space.

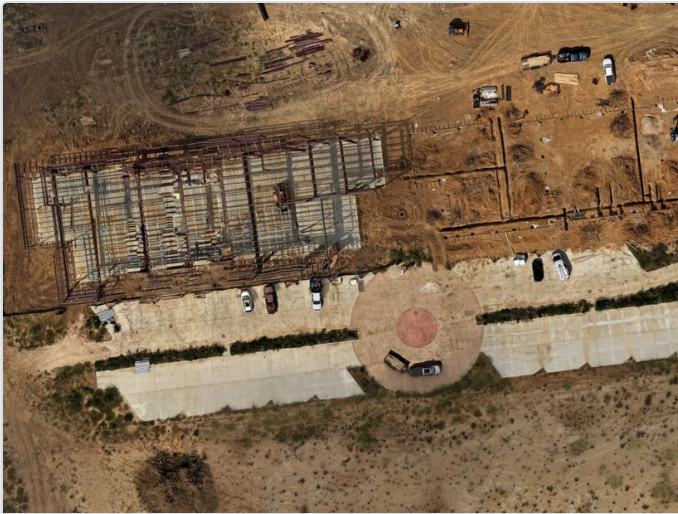
**FIG. 06** Retail 4 steel frame and slab.

| PARCEL | PROGRAM | STATUS | PROGRESS | OBSERVED 2026-10-06 |
|---|---|---|---|---|
| ■ Retail 4 | 12,000 SF | STEEL ERECTION | <div><div></div></div> 60% | Slab complete. Columns and roof framing erected a the full footprint; r decking, walls or envelope yet. Telehandler on the |

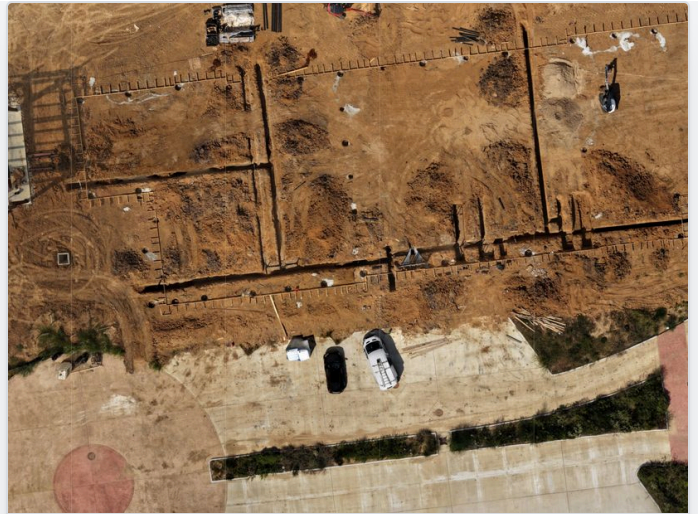
- **Retail 5 has gone from a bare cut to footing layout** — individual footing pits excavated, stake and string lines set, forming lumber and rebar bundles staged beside the pad.

**FIG. 07** Retail 5 footing excavations and spoil.

| PARCEL | PROGRAM | STATUS | PROGRESS | OBSERVED 2026-10-06 |
|---|---|---|---|---|
| ■ Retail 5 | 12,000 SF | FOOTINGS | <div><div></div></div> 22% | Footing excavation dug with stake and string lines set; lu and rebar staged. a bare cut on 9/24 |
